Water Distribution System Integrity Study

Huber Heights, Ohio

Public Water System OH5703612

February 2023

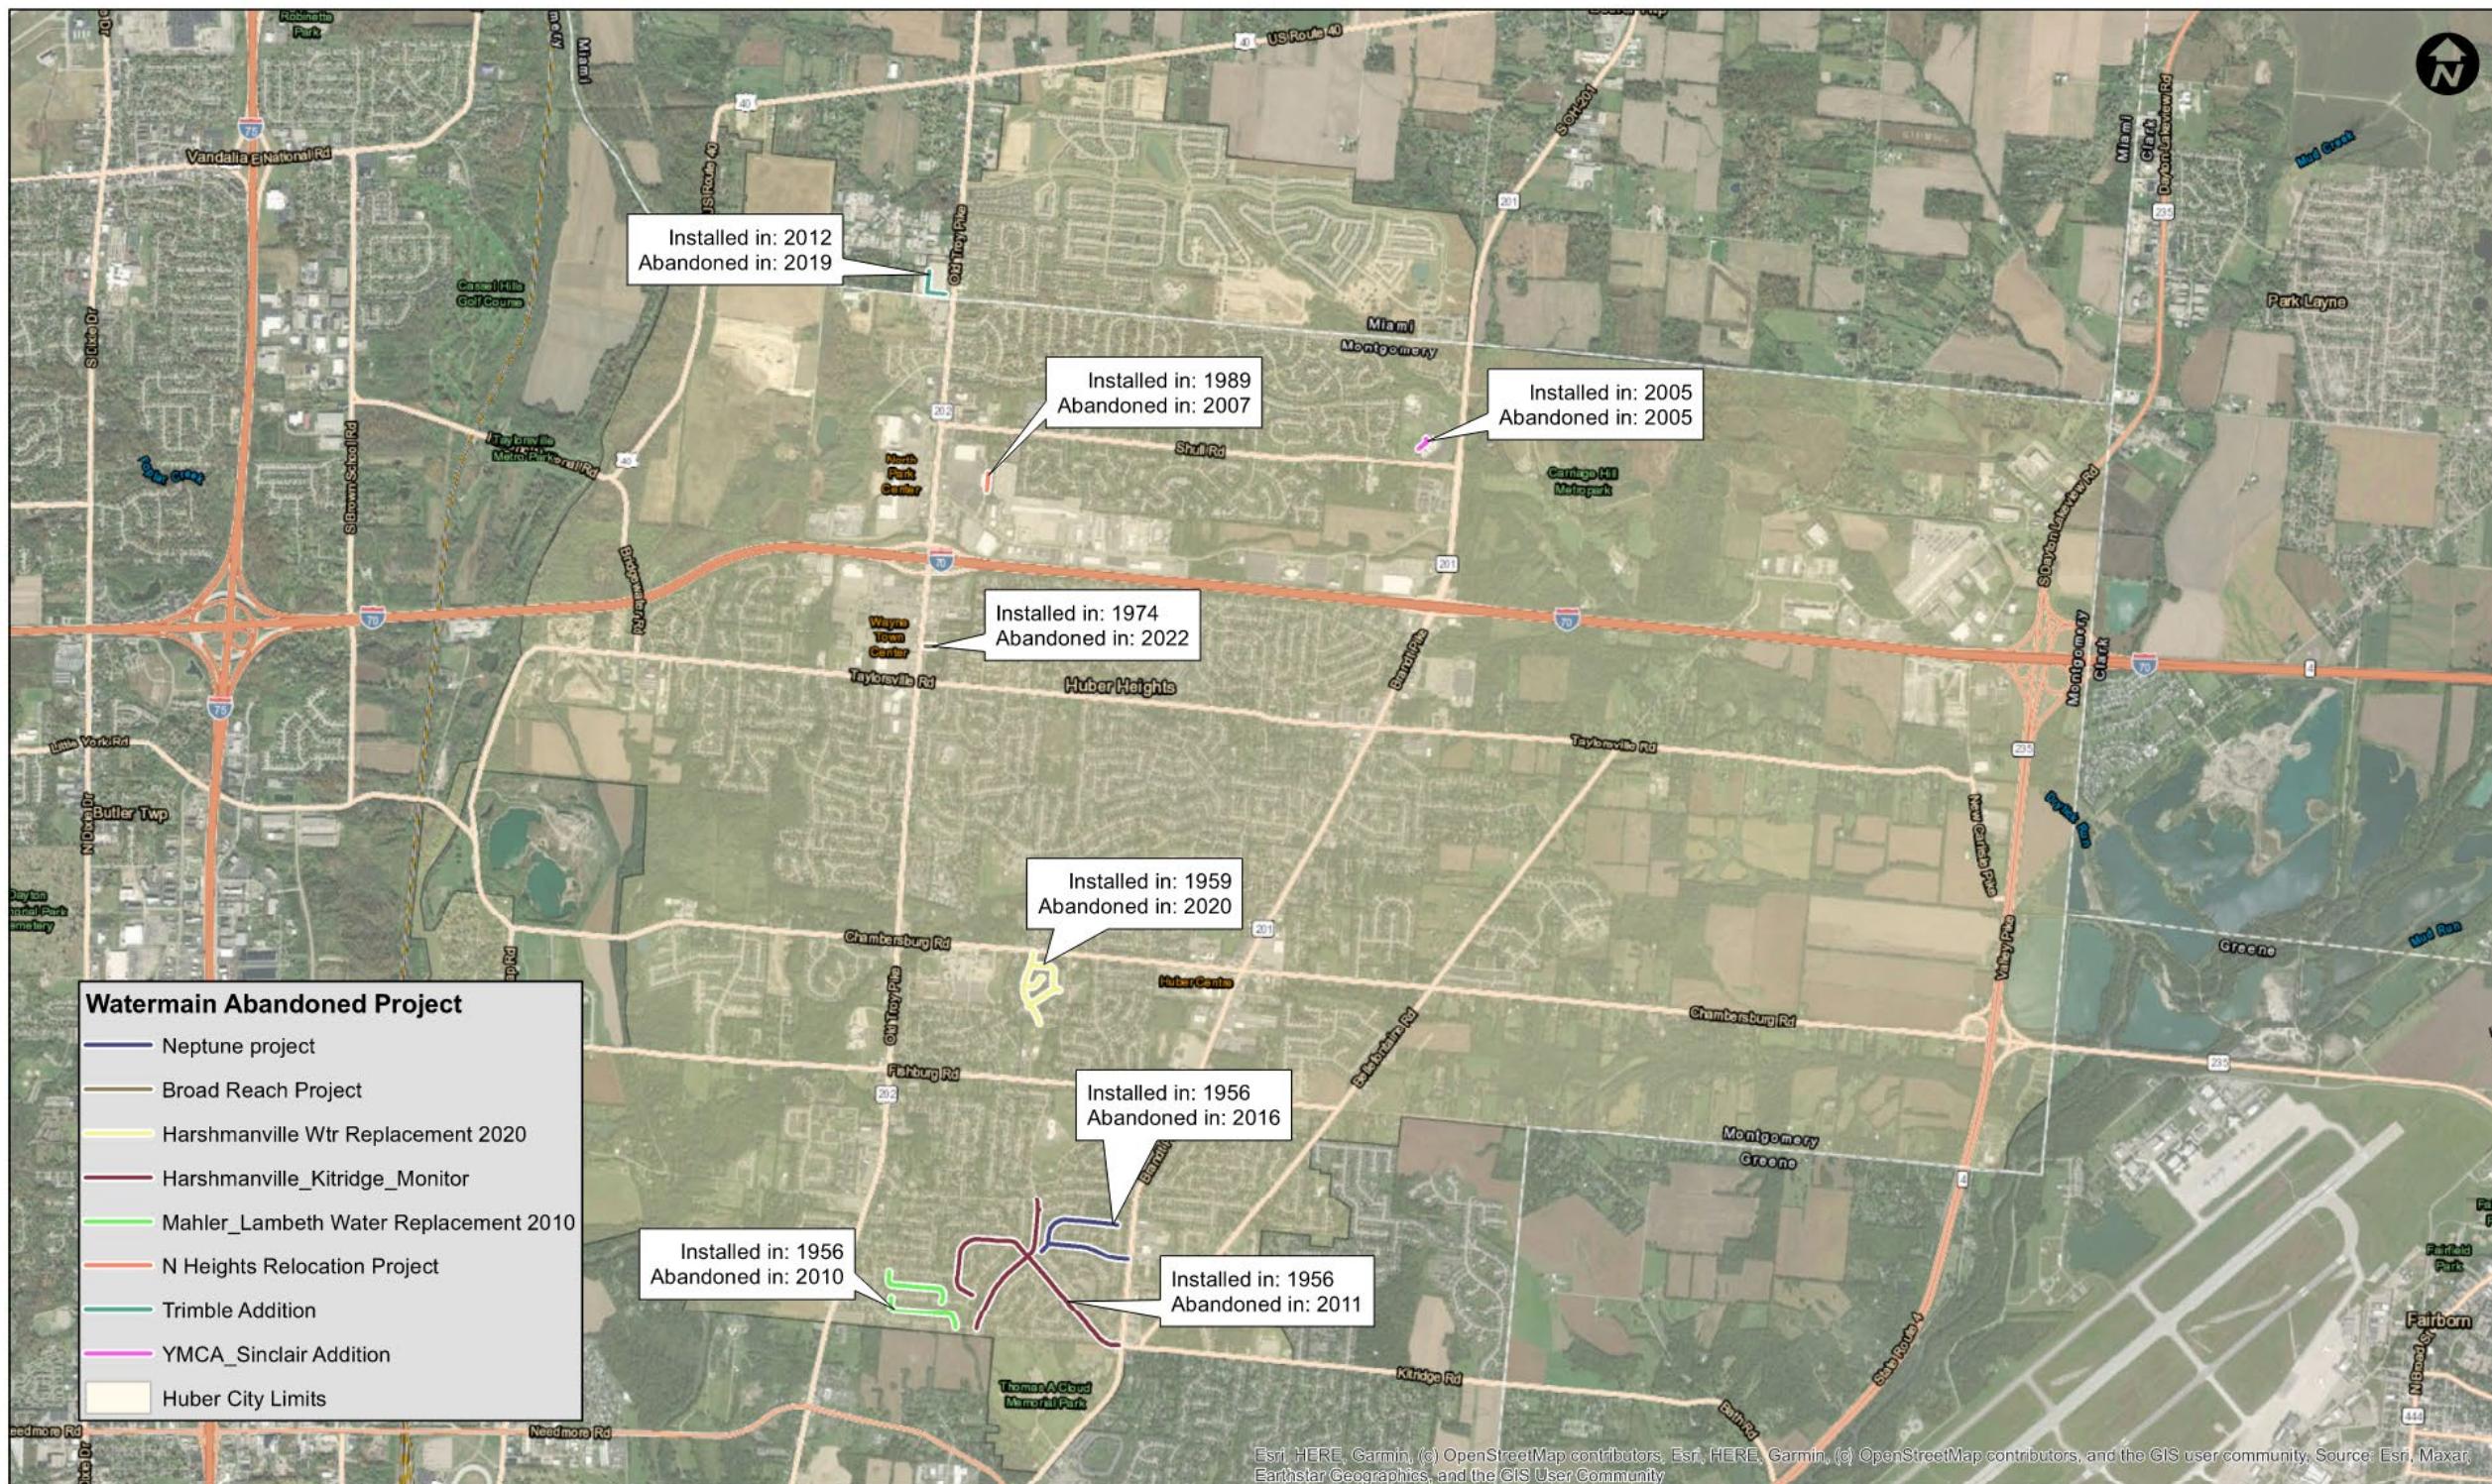
Figure 2-4. Abandoned Watermain Locations

Including abandoned watermains in the analysis of pipe break rates is very important as it provides more informed predictions of future pipe longevity of active pipe, particularly with understanding of how the break rate for different pipe cohorts accelerates near the end of their useful lives. Based on available data provided by the City, **Table 2-4** summarizes the breakdown of abandoned watermain attributes. A map of abandoned pipes is shown in **Figure 2-4**. Watermain abandonments were predominantly cast iron (92.1-percent) with some ductile iron (DI) replacement (7.9-percent). A more detailed description of abandoned watermains can be found in **Appendix B**.

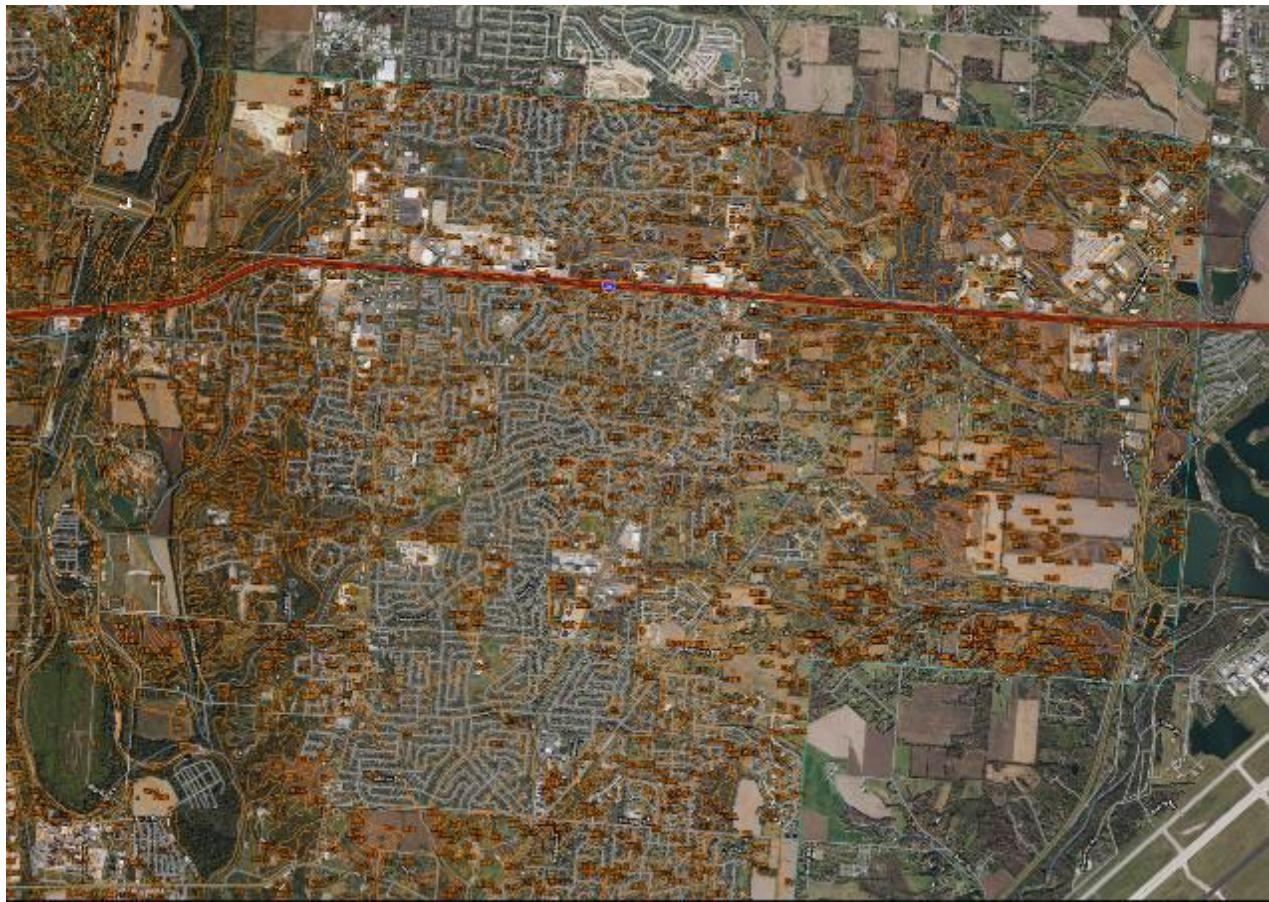
Figure 3-13. Soil Type Map for Northeast Montgomery County

B&N utilized the US Department of Agriculture - Natural Resources Conservation Service soil survey database to access information about the corrosiveness of native soils in Huber Heights. This database was updated in September 2022. An example of the soil type data for Huber Heights within Montgomery County is shown in **Figure 3-13**. While the soil types shown in this figure are not legible as shown, it is the subsequent maps that illustrate the properties of those soils that are relevant to this study.

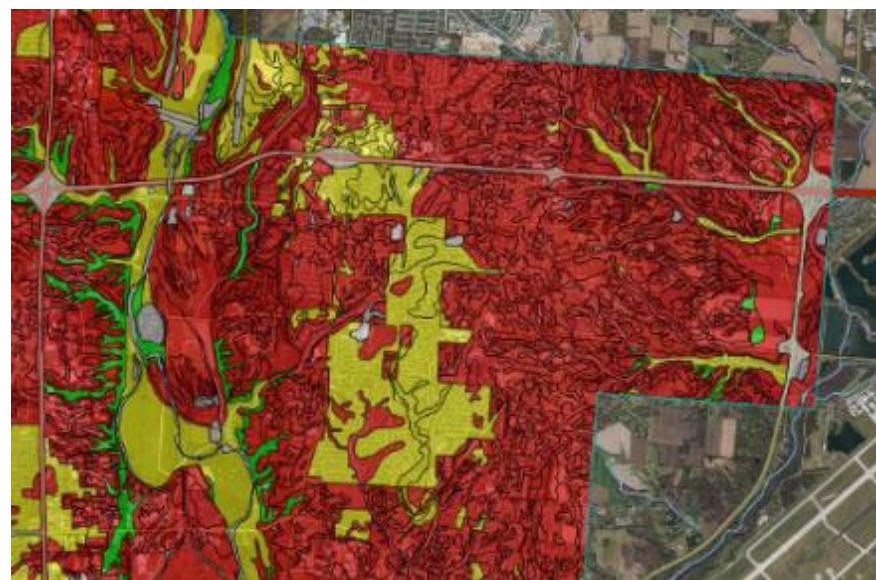
The soil database also assesses the “risk of corrosion to steel” in a single parameter that pertains to potential soil-induced electrochemical or chemical action that corrodes or weakens uncoated steel. The rate of corrosion of uncoated steel is related to such factors as soil moisture, particle-size distribution, acidity, and electrical conductivity of the soil. The risk of corrosion is expressed as “low,” “moderate,” or “high”. While iron can develop a patina to inhibit corrosion of the metal’s integrity, potentially giving it better corrosion resistance than steel, the failure morphology for steel and iron watermains is similar (“Control of External Corrosion of Iron and Steel Watermains”, R.A. Gummow, 2004). This parameter is, therefore, applicable to iron pipes. For Huber Heights, soils are either highly or moderately corrosive to metal (See **Figure 3-15**). There are not soils in Huber Heights that have low corrosion for steel.

Figure 3-15. Risk of Soil Corrosion for Steel (Montgomery County only)
(Yellow = Moderate Corrosivity for Steel; Red = High Corrosivity for Steel)

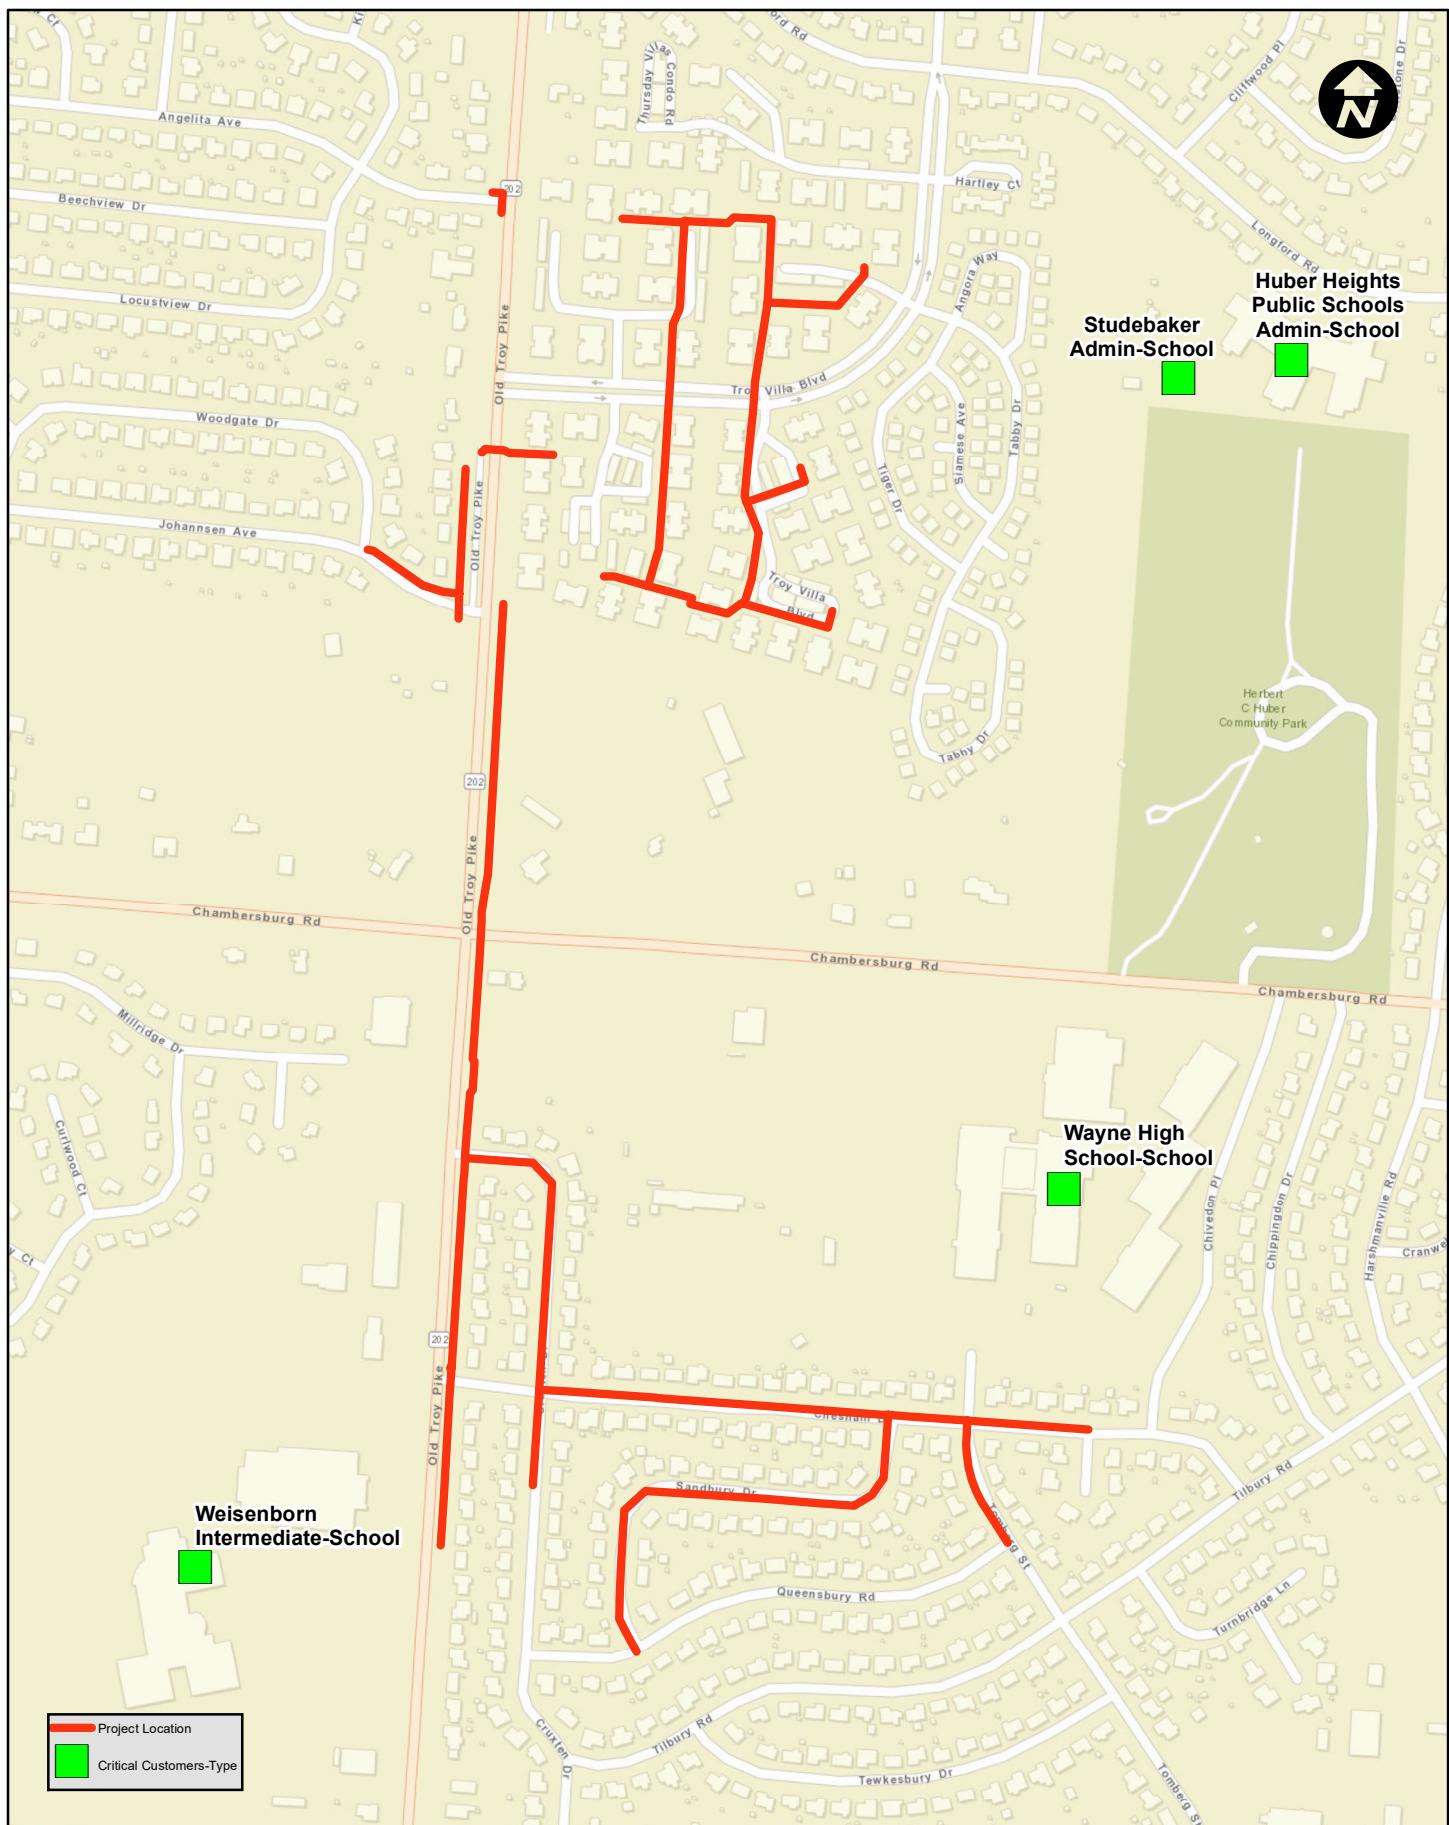
Project 1

Project BCR Ratio: 2.41

Replacement Cost (\$) Total: 3,813,453

50-year Risk (\$): 9,199,794

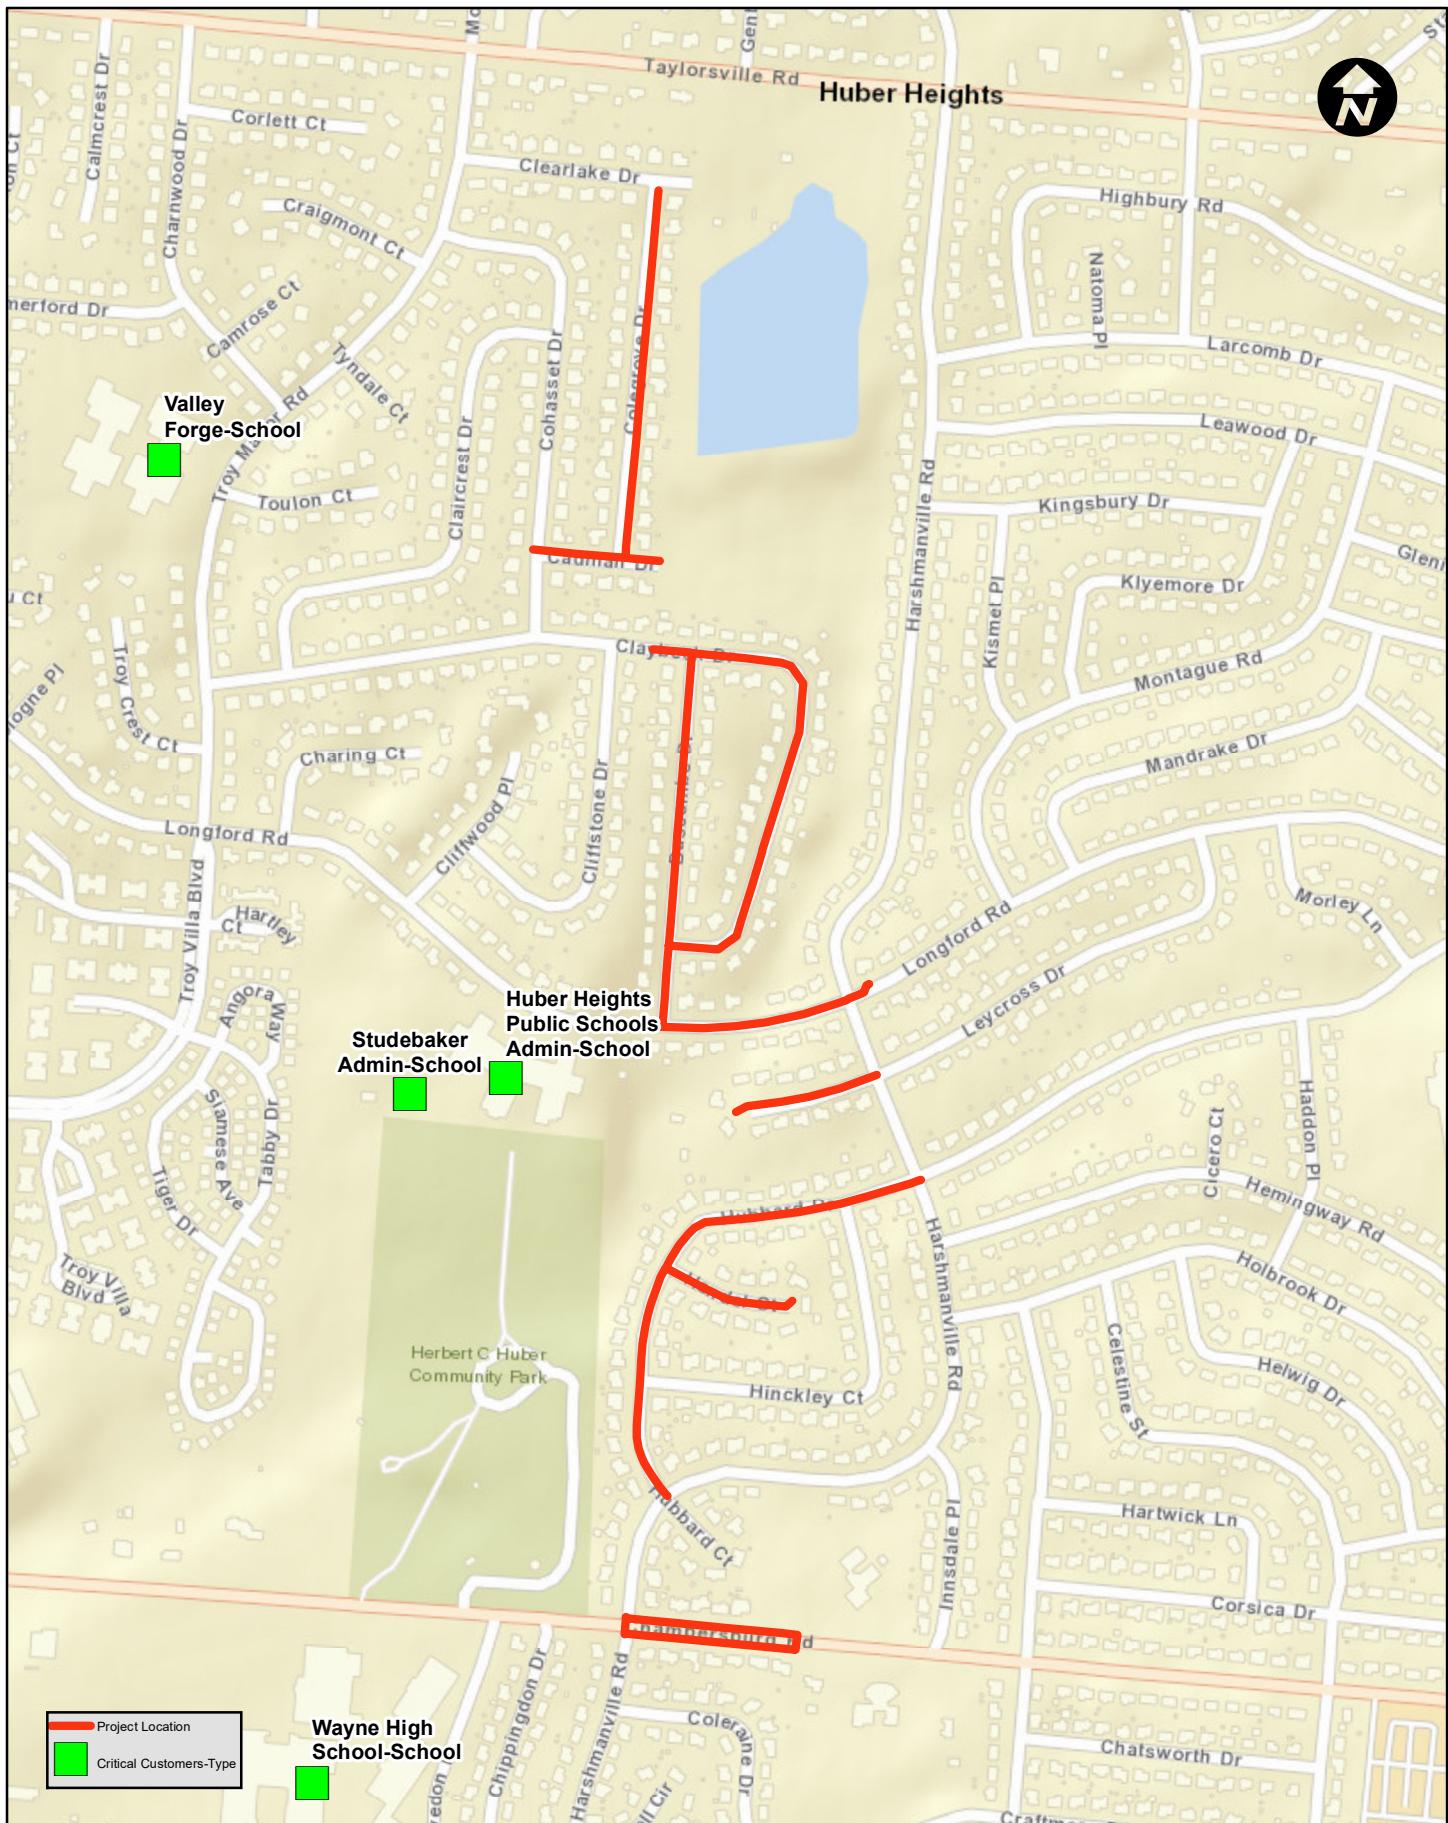
Pipe ID	Material	Diameter (Inches)	Installation Year	Number of Breaks in Past
WM00784	PCP	16	1959	1
WM00785	Cast Iron	6	1959	1
WM00790	Cast Iron	6	1959	0
WM01218	Cast Iron	6	1968	0
WM01219	Cast Iron	6	1968	0
WM01220	Cast Iron	6	1968	0
WM01221	Cast Iron	6	1968	0
WM01222	Cast Iron	6	1968	0
WM01223	Cast Iron	6	1968	0
WM01224	Cast Iron	6	1968	0
WM01225	Cast Iron	6	1968	1
WM01744	Cast Iron	6	1968	0
WM02286	Cast Iron	6	1960	3
WM02287	Cast Iron	6	1960	0
WM02288	Cast Iron	16	1960	0
WM02289	Cast Iron	6	1960	10
WM02306	Cast Iron	6	1960	0
WM02307	Cast Iron	6	1960	8
WM02310	Cast Iron	6	1960	1
WM02312	Cast Iron	6	1960	0
WM02313	Cast Iron	6	1960	15
WM02314	Cast Iron	6	1960	0
WM02315	Cast Iron	6	1960	11
WM02316	Cast Iron	6	1960	4
WM04401	Cast Iron	10	1960	11

Replacement Cost (\$) Total: 2,698,415

50-year Risk (\$): 5,066,936

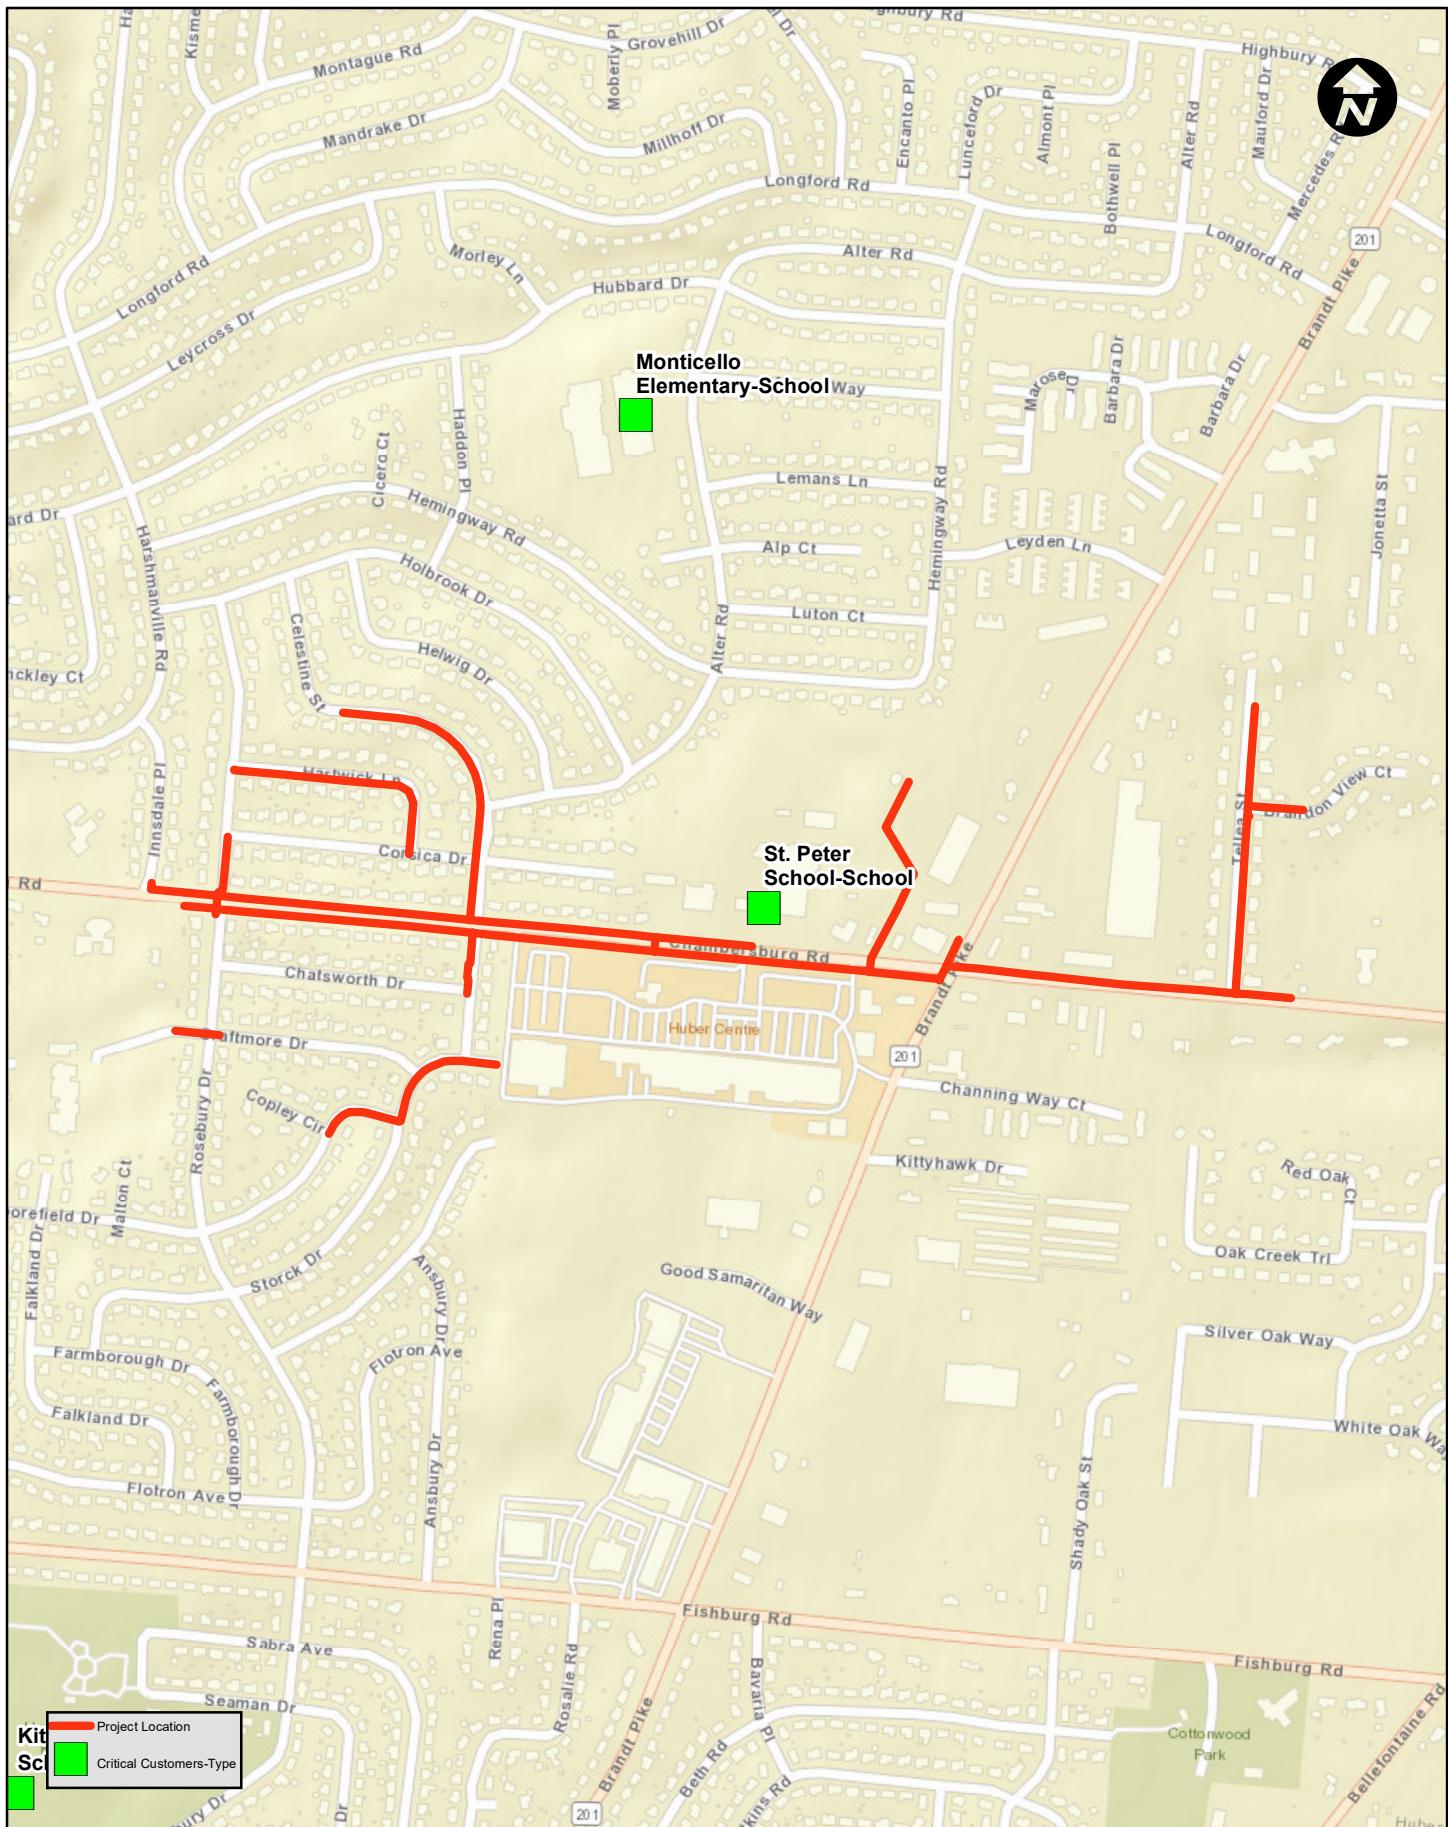
Project 3

Project BCR Ratio: 1.55

Replacement Cost (\$): 4,356,366

50-year Risk (\$): 6,767,785

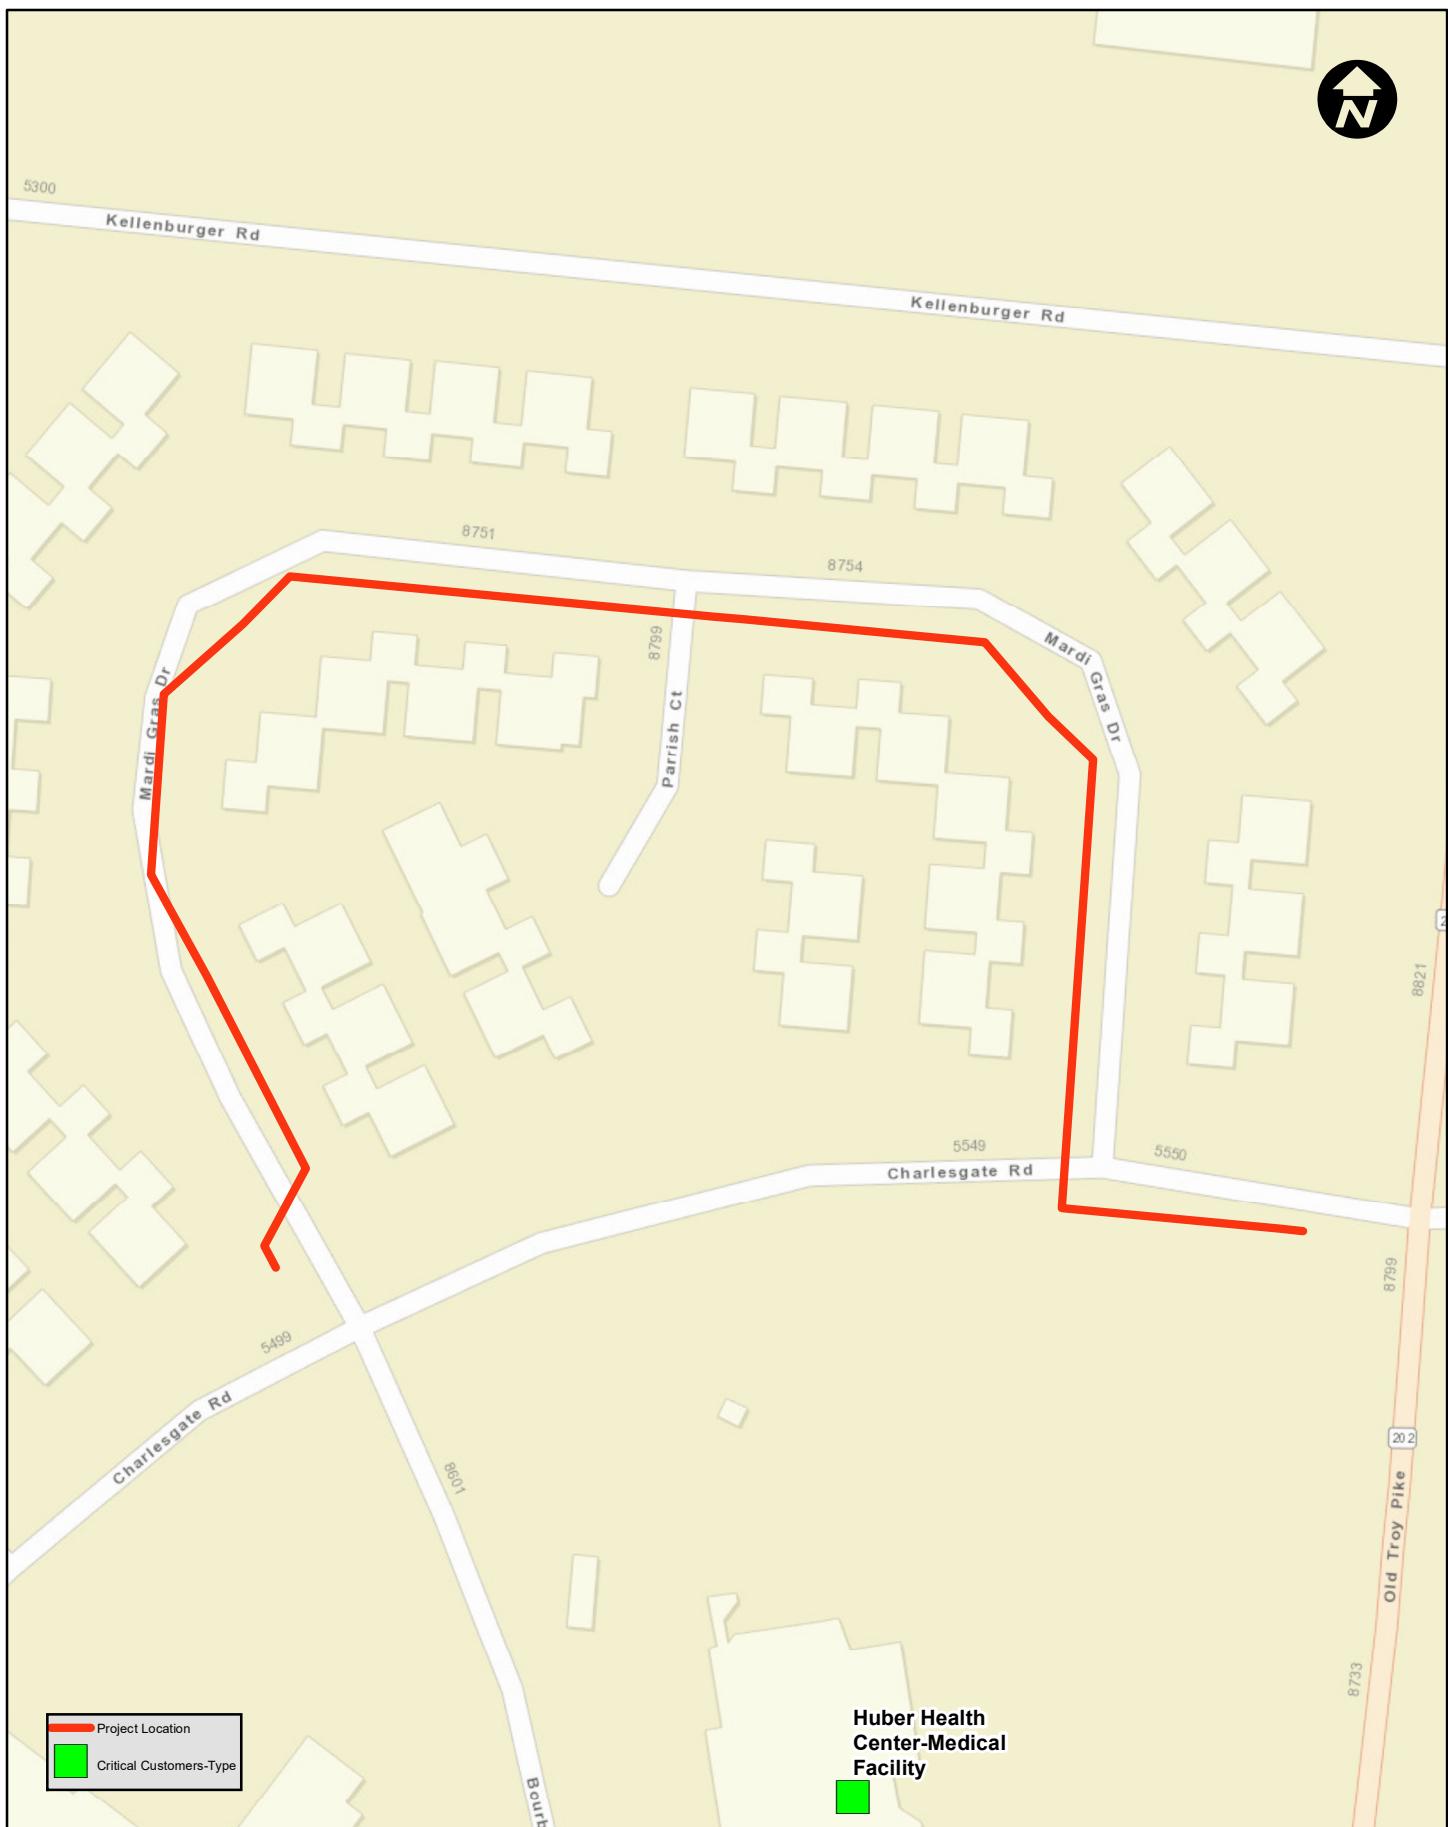
Project 16

Project BCR Ratio: 0.11

Replacement Cost (\$): 351,300

50-year Risk (\$: 40,123
